FEDERAL BUILDING (NM0024ZZ) 517 GOLD AVENUE, SOUTHWEST ALBUQUERQUE, NEW MEXICO

ASBESTOS BUILDING AUDIT SURVEY CC: TPMF - AQ

SEPTEMBER 5 - 15, 1995

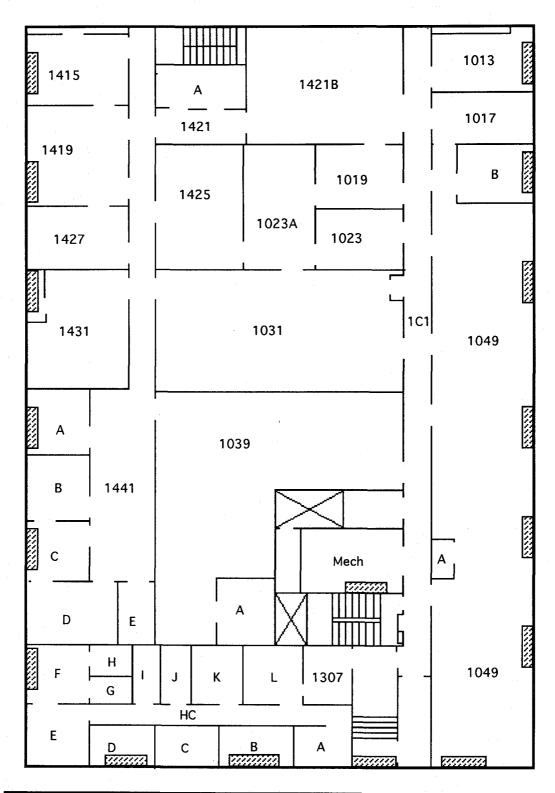
First Floor - West

Suspected steam
fitting insulation
feeding radiators.
